GENERAL AND REVENUE SECRETARIAT.

Guilding the 9 Kalasas of the Sri Ranganathaswamy temple at Srivangapatam.

List of correspondence connected with the repair of Ranganadaswami temple at Srirangapatna.

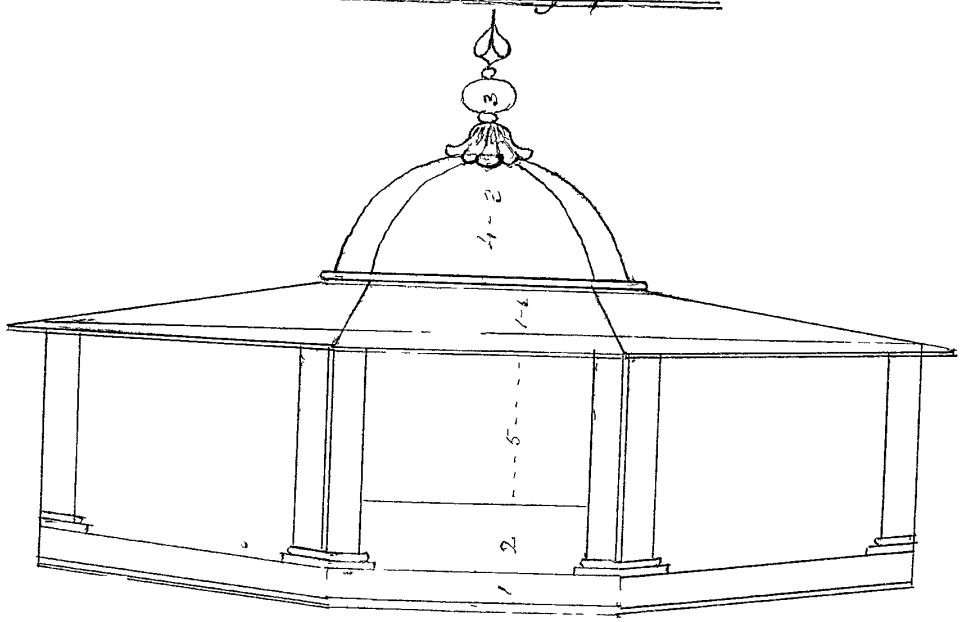
PLAN

The old Mantlup was situated in a corner of the Story and the deity when placed in it could not be seen from all parts of the temple. The building was an ugly structure and being also in a delapidated condition was ordered to be pulled down by the Dewan.

Vymálege muntup

Proposed
to be
constructed
in the
Runganathaswamy's Temple
at
Sreerungapatna

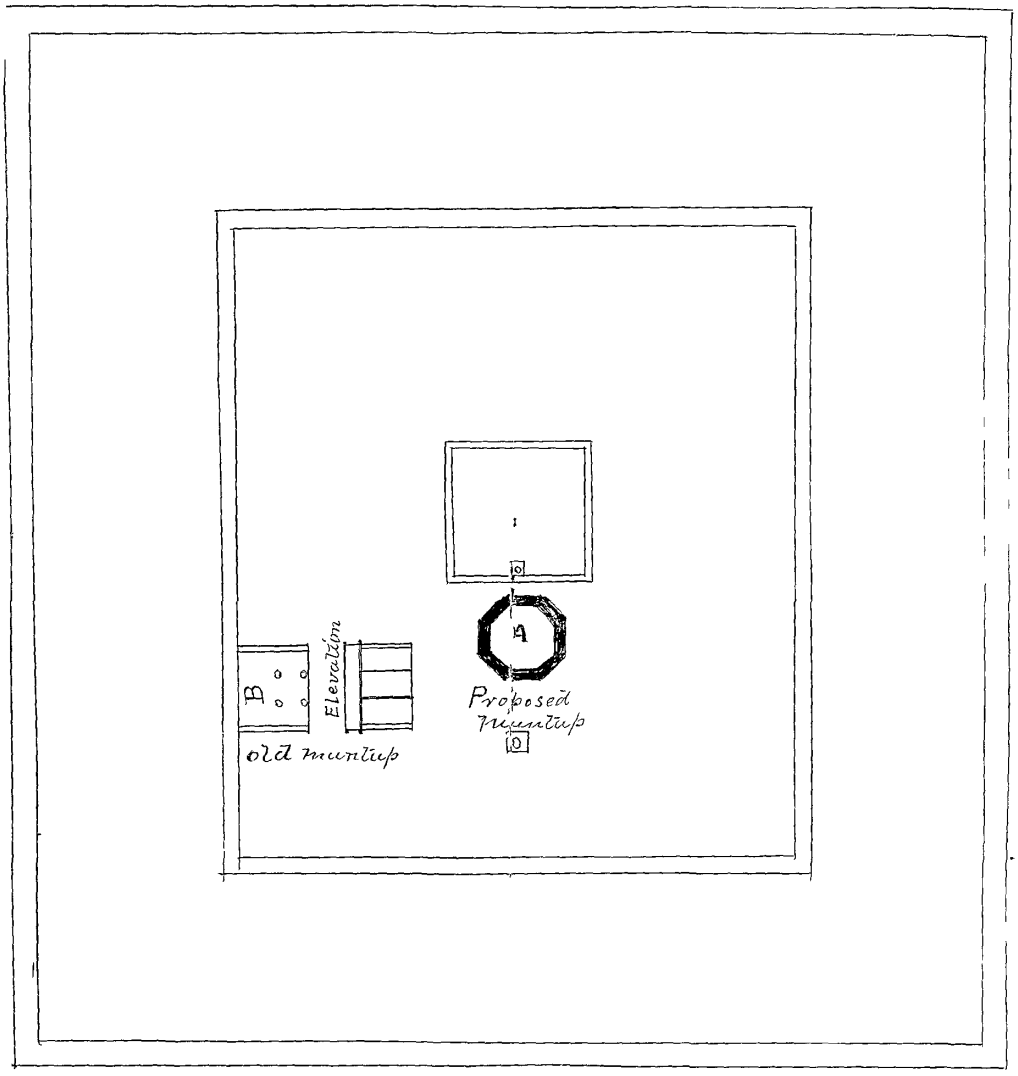
ROUGH SKETCH

Ringarathaswamy's Temple

Sreerungapatna.
